# Manhole Inspection Summary

Manhole # S27K\_\_004MH

Insp Date: **6/3/08 9:03 AM**

**Location** Address: **855 S Poppleton St**

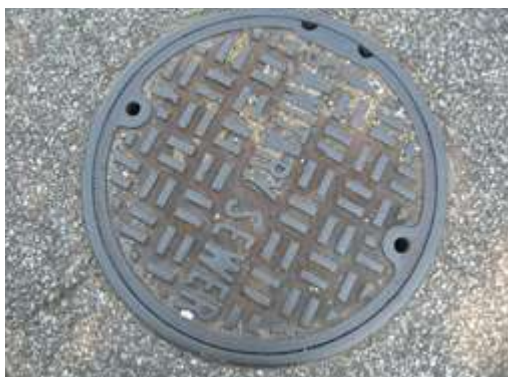
Cover View

Condition: **Sound**

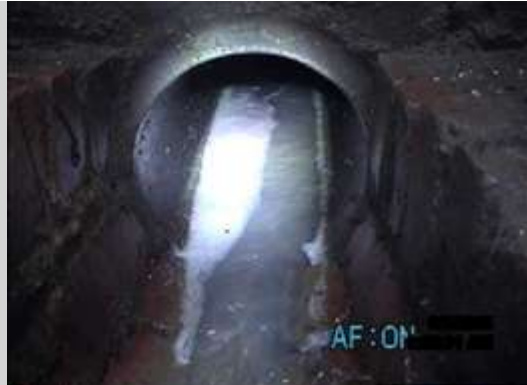
12 O'Clock Outflow

8 in. Circular Gravity Sewer  
Pipe Out @ 12 O'Clock

Pipe Height: **8.4** (in.) Rod and Bar (Angled)  
Pipe Material: **Clay** ☐ Pipe Lined  
Invert Depth: **7.52** (ft.) Flow Characteristics: **Fast**  
Deposits: ☒ None ☐ Mud ☐ Sludge ☐ Debris ☐ Grease  
Silt Depth: **0** (in.) Deposits Extent:  
Infiltration: **None** Pipe Seal Cond: **Sound**

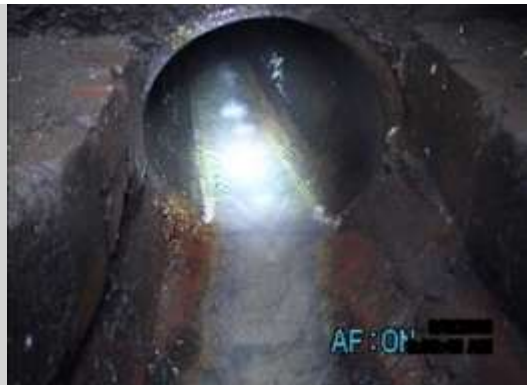
4 O'Clock Inflow

8 in. Circular Gravity Sewer  
Pipe In @ 4 O'Clock

Pipe Height: **8.4** (in.) Rod and Bar (Angled)  
Pipe Material: **Clay** ☐ Pipe Lined  
Invert Depth: **7.35** (ft.) Flow Characteristics: **Slow**  
Deposits: ☒ None ☐ Mud ☐ Sludge ☐ Debris ☐ Grease  
Silt Depth: **0** (in.) Deposits Extent:  
Infiltration: **None** Pipe Seal Cond: **Sound**
